Probing into fumes

The gas industry has agreed 'best practice' for the use of portable electronic combustion gas analysers (ECGAs). This article reviews the recommended procedures, the typical features of the instrumentation, and presents a scenario that illustrates the way an operative can use such an instrument to best effect in dwellings when responding to a report of fumes.

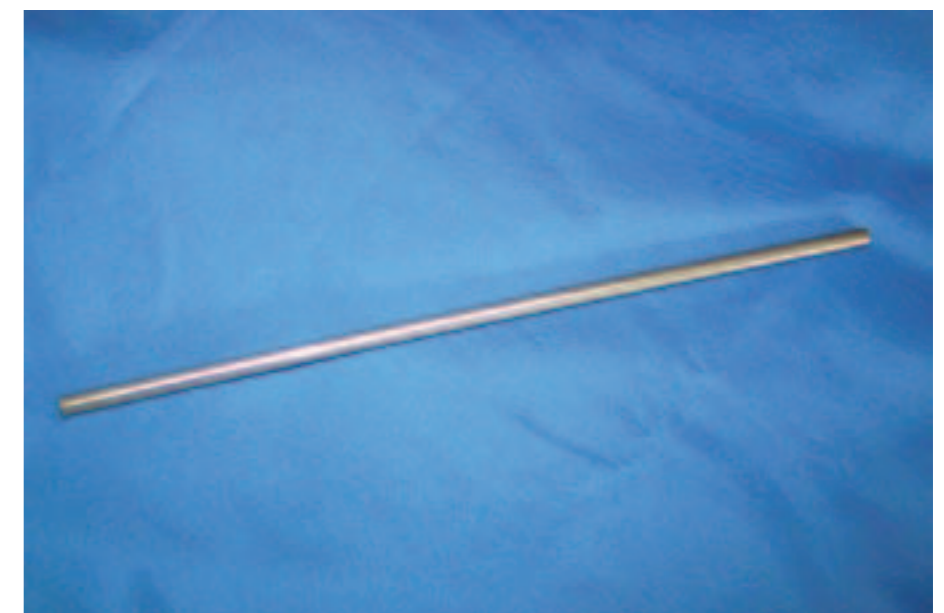
Figure 1. Typical openended sampling probe

A further consideration when using instrumentation is the design of sample probes to be used in different situations. Typically, an open ended probe (see Figure 1), often made from rigid stainless steel, comes supplied with the ECGA. The flexible silicone tubing through which the sample passes between the probe and the measuring instrument allows for probes to be interchanged. Instances where the design of probe is important to obtain good representative measurements are:

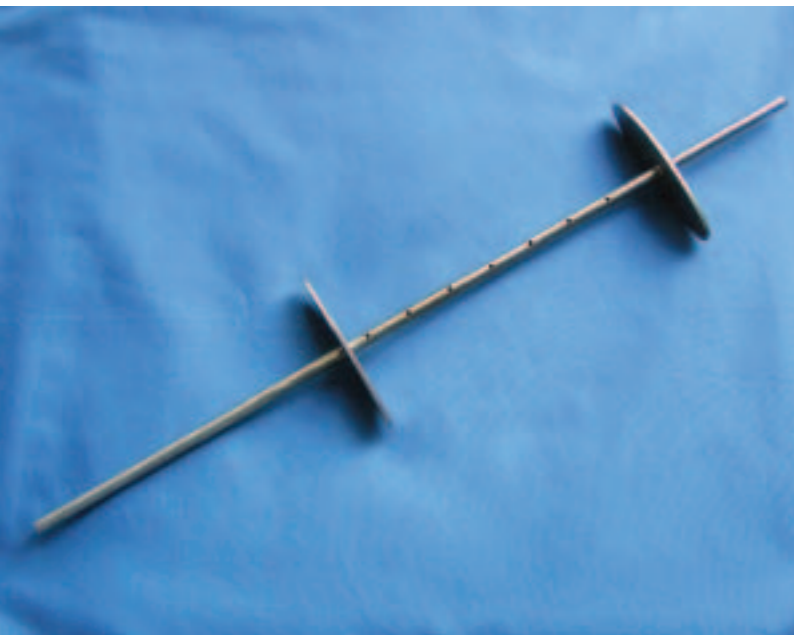
Figure 2. Typical cooker sampling probe

- Where a free-standing kitchen grill has to be sampled, combustion products flow out across an area approximately 20cm by 5cm. Here, representative sampling can be achieved using a multi-hole probe that can be placed on top of the outlet (see Figure 2 on following page)
- Where sampling of combustion products flowing through an outlet, for example from a flueless sink water heater, a multi-hole probe can provide representative concentration measurements (see Figure 3 on following page).

A combustion test is carried out on the grill using the special grill probe (figure 2) and confirms there are no problems. The oven combustion is checked using the multi-hole probe and a visual inspection of the hotplate burners confirms there are no concerns with the cooker operation.

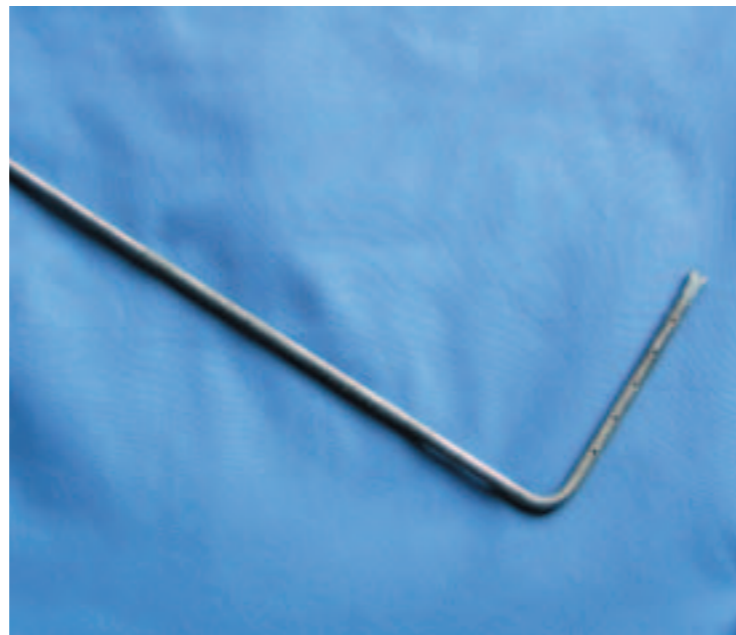
Figure 3. Typical angled multi hole sampling probe
